Upgrading and re-engineering of Cowans Sheldon 75 tonne Railway Breakdown Cranes

- Refurbishments
- Enhancements
- Spare Parts

factsheet

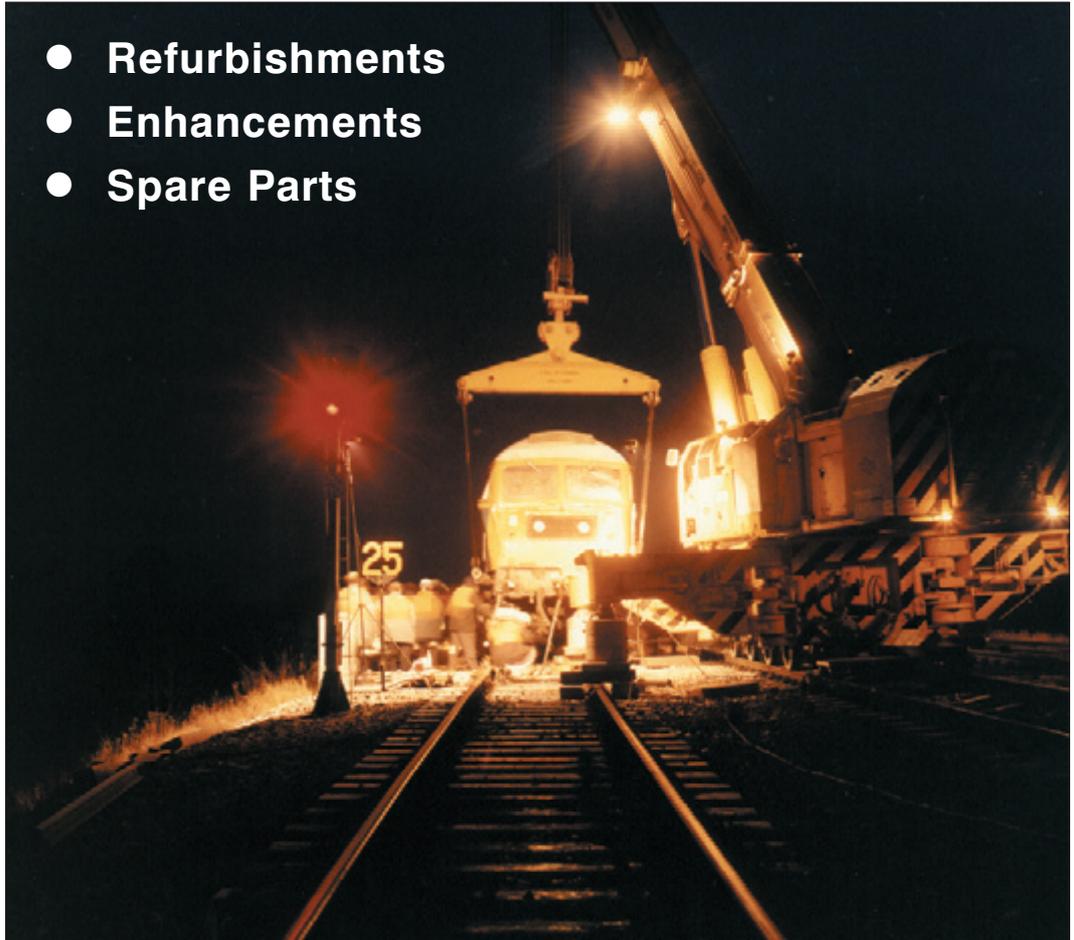
The cranes, originally supplied in the 1970's, were becoming increasingly unreliable and requiring more maintenance. The obsolescence of much of the equipment was also prohibiting spares support. A total overhaul and refurbishment has extended the service life of these cranes by another 20 years and incorporated safety modifications to bring

the cranes up to mandatory requirements. On arrival at our factory, the cranes were stripped down to their individual components parts and bare metals. Non destructive testing was carried out to confirm structural integrity. The hydraulic rams and ancillary hydraulic equipment were refurbished, as were all drives and gearboxes.

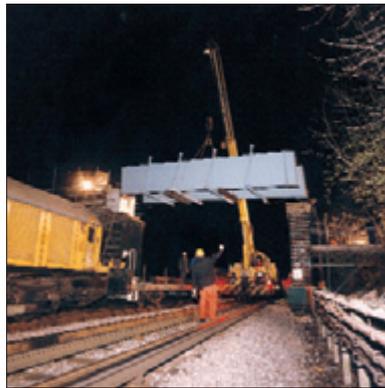
Upgrading and re-engineering of Cowans Sheldon 75 tonne railway breakdown cranes.

A number of reliability and environmental as well as statutory improvements were made.

- A new diesel engine, coupled with an enhanced hydraulic pump arrangement, was fitted, improving performance, reliability and spares support and reducing maintenance requirements.

- A history of fatigue failures in the slew ring bolts resulted in repeated replacement at high cost. An improved design was manufactured and fitted.
- A new automatic safe load indicator (ASLI), complying with BS 7262:1990, was fitted, thereby removing unsafe working practices.

- Six brake disks were added to the existing wheelset configuration, coupled with improved brake materials and calliper/actuators. This modification improved brake performance and reduced thermal input and degradation to disks and pads.

- Better floodlighting and general work area fluorescent lights were introduced to improve the working environment and hence safety.
- A new operator's cab with improved entry and exit, mounted on anti-vibration mountings was fitted and a rear facing video monitor to improve the operator's all round vision. To improve communication with the ground crew a radio and public address system were installed.

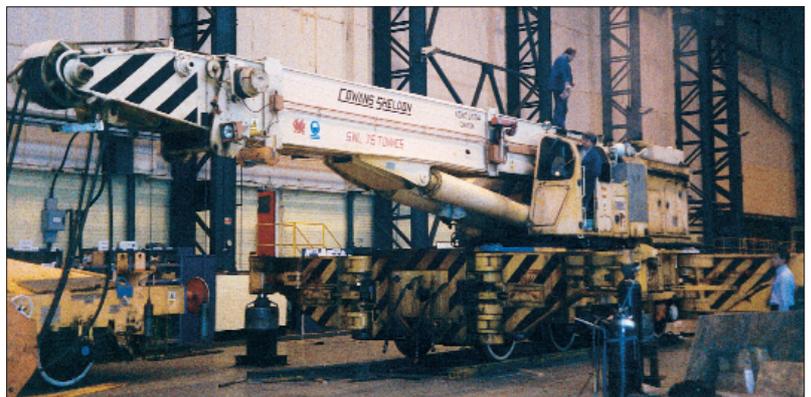
30 year old breakdown crane...

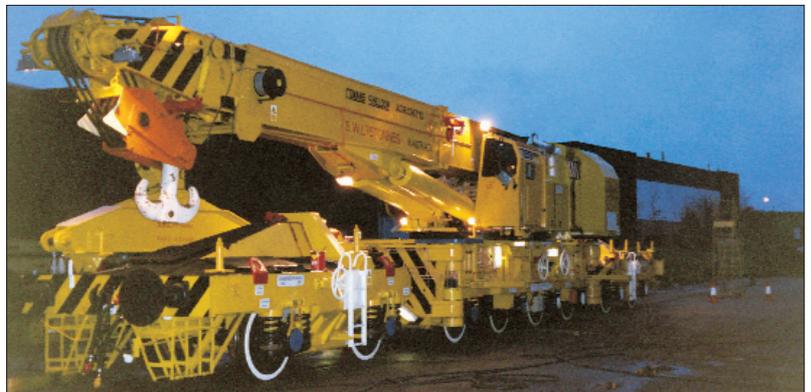
...given a new lease of life.
